# ECODRIVE Drive Controller DKC02.1

Trouble Shooting Guide: SSE 03VRS

DOK-ECODRV-SSE-03VRS\*\*-WAR1-EN-P

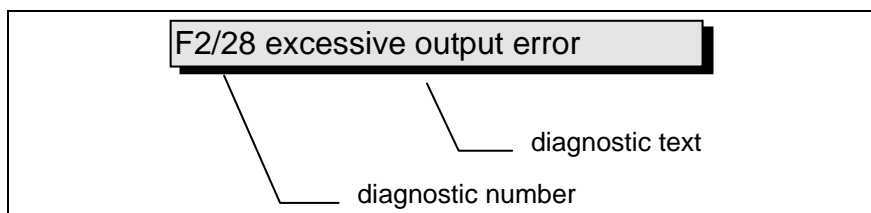
Fig. 1-1: Diagnostic message makeup: a diagnostic message number and text.

In the example shown above, "F2" and "28" alternate in the H1 display.

Plain text diagnostic messages contain the diagnostic number followed by the diagnostic text, as shown in the example, "Excessive output error" (Fig. 1-1).

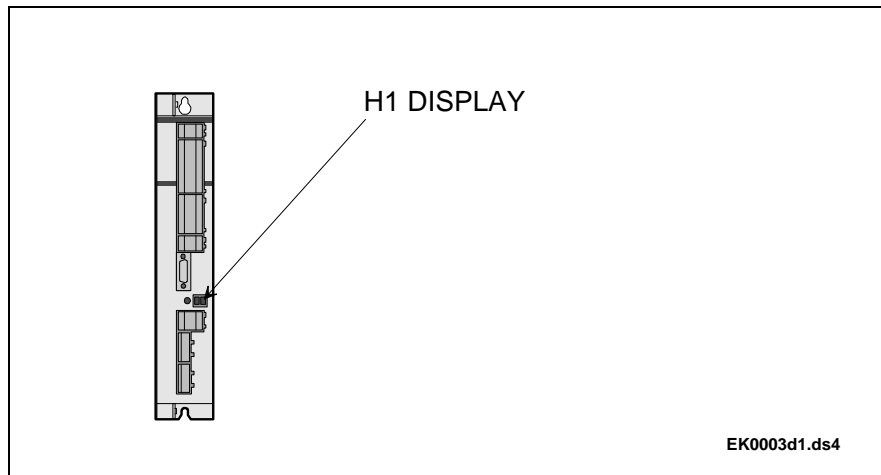
Fig. 1-2: H1-Display

An icon representing the diagnostic number appears on this two-place seven-segment display. The arrangement of the display is based on the "Diagnostic message priority display" screen.

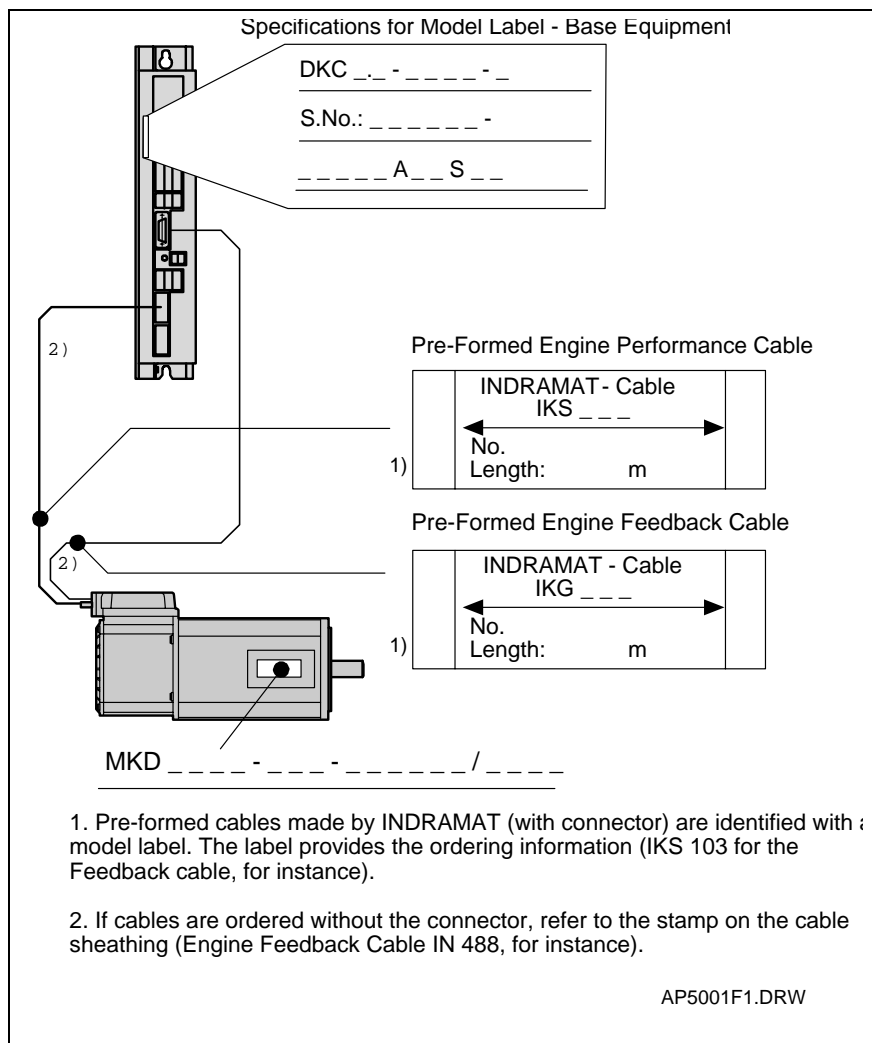
The identification plate for MKD motors is on the right side of the motor (when you are looking at the motor shaft with the motor connection box on top).

Assembled cables are supplied with a label (cable mark) that carries the cable number and the length of the assembled cable.

Fig. 6-1: Code description of the drive components

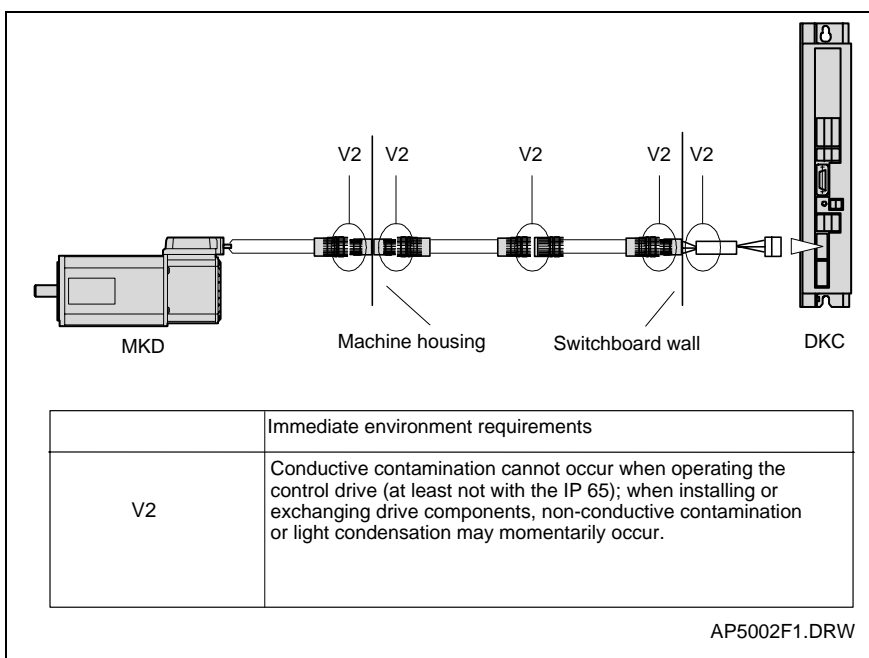
**Note:** When the cables are exchanged, open connectors from power connections should be covered with protection caps to protect against the spread of coolant, lubricating fluid or dirt (adm. protection level V2).

Fig. 6-2: Contamination level according to DIN VDE 0160

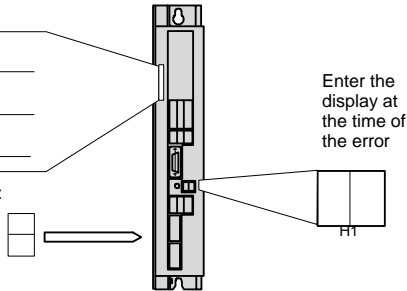
Enter the display at the time of the error
